**Results of the Radiological Survey  
at the Former Associate Aircraft  
Tool and Manufacturing Company  
Site, Fairfield, Ohio  
(FOH001)**

HEALTH AND SAFETY RESEARCH DIVISION

Publication issued — March 1993

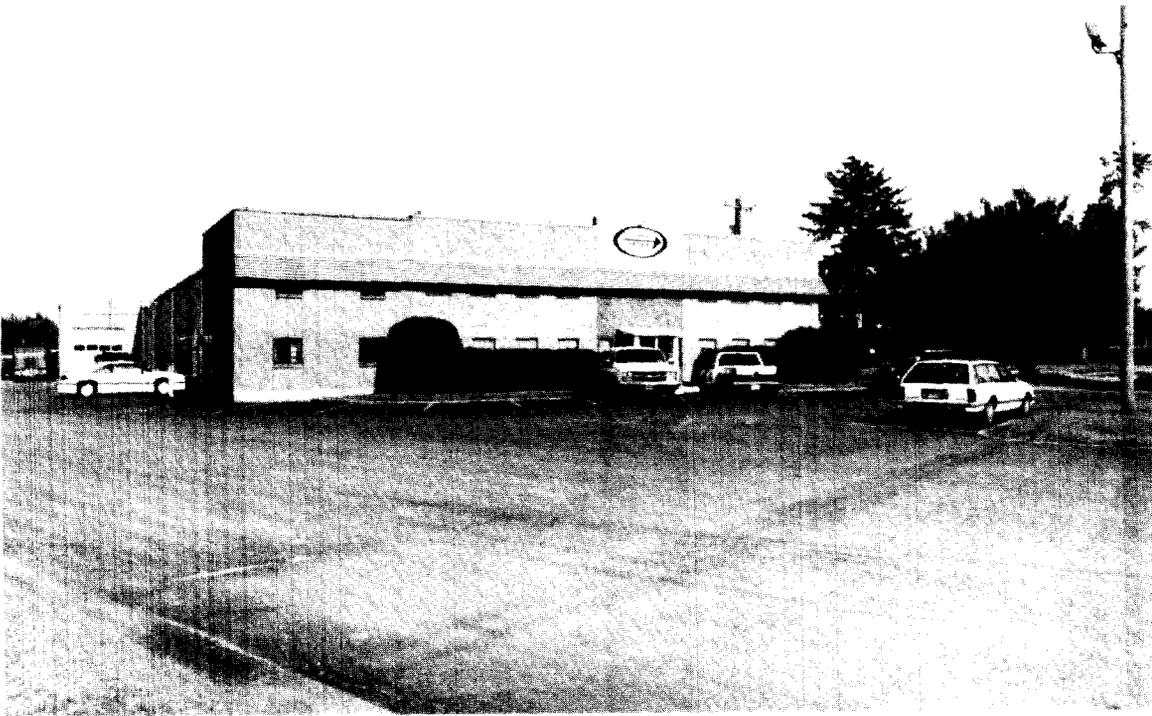
Photographs of the front of the building as it appeared in July and September 1992, respectively, are provided in Figs. 2 and 3. The ground surface directly in front of and west of the building was thoroughly surveyed in July prior to the construction shown in the second photograph. The complete radiological characterization of the building and of a 25-ft-wide perimeter of ground surface around the remaining three sides of the building was performed in September, 1992. The results of the two surveys are combined in this report. The approximate outdoor areas surveyed west of the building are diagrammed in Fig. 4. Figure 5 shows a floor plan of the building and indicates the six arbitrary sections into which it was divided, east to west, for purposes of identifying and locating measurements and samples. Most accessible indoor areas were scanned, and equipment and materials were moved aside wherever possible to allow access for surveying. At the time of the surveys, the owner operated a multipurpose machine shop in the facility.

**Fig. 2. View of the building at the former Associate Aircraft site, looking east (July 1992).**

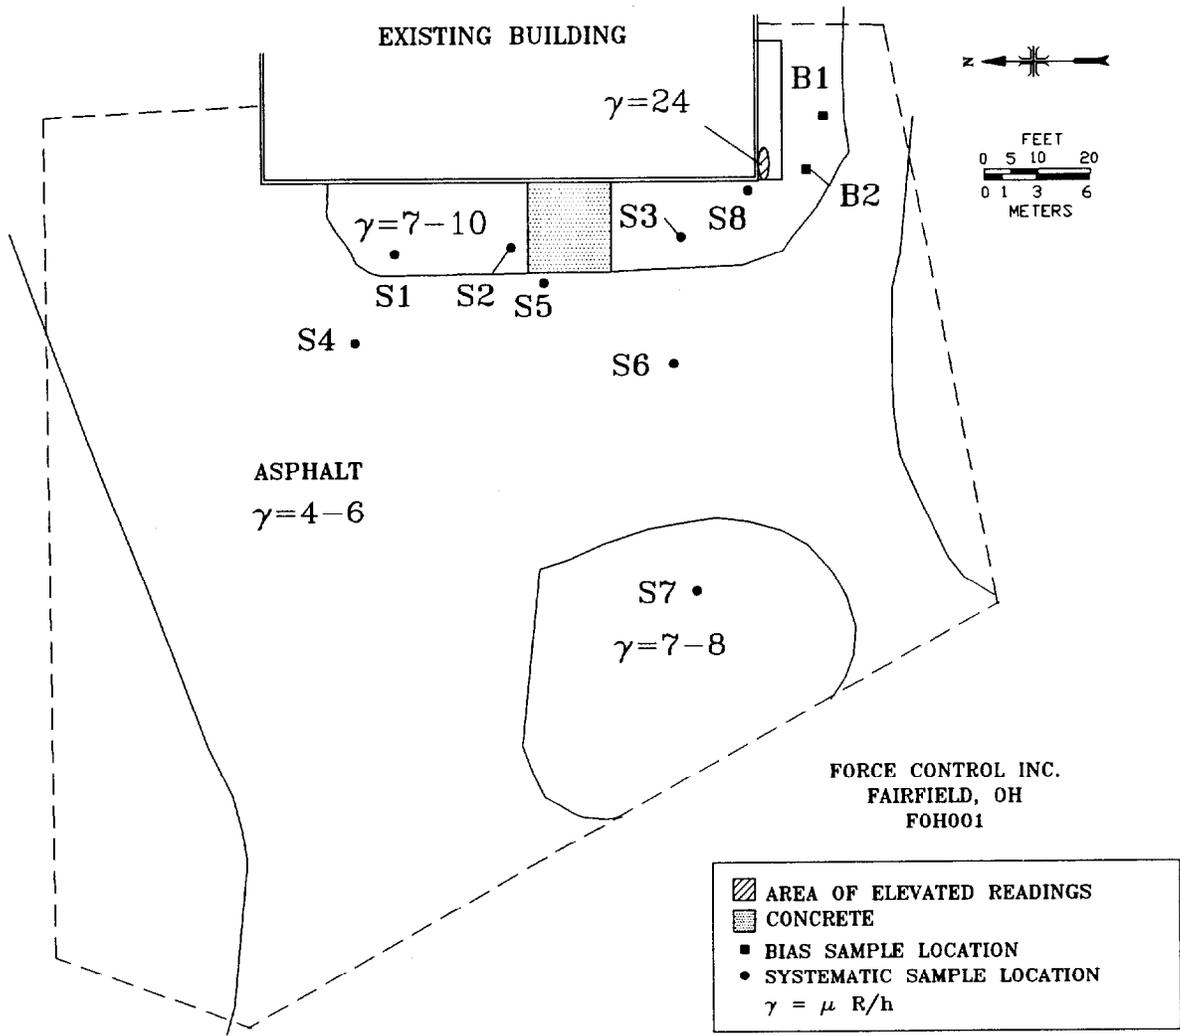
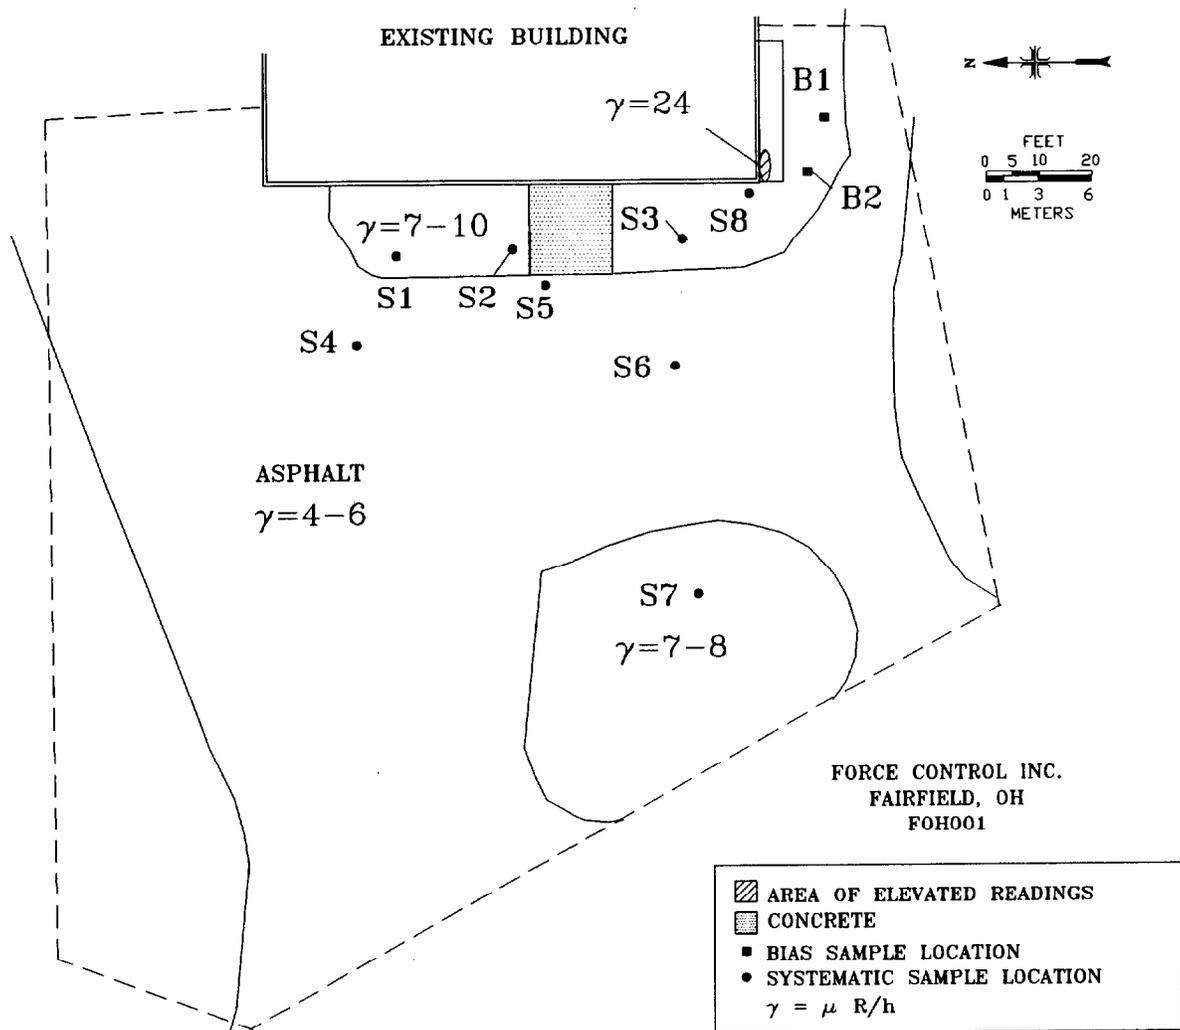
Results of the ground surface gamma scans are shown on Fig. 6 (July survey) and Fig. 7 (September survey). Because this was a designation survey, the outdoor surveying was generally limited to an area 10- to 30-ft from the building. Surface gamma exposure rates generally ranged from 4 to 10  $\mu$ R/h, values comparable to the typical range of background radiation levels in the Fairfield, Ohio, area (3 to 11  $\mu$ R/h, Table 2). Exceptions were found in several isolated locations, of which two are particularly notable. A small area at the southwest corner of the building showed gamma levels of 16 to 24  $\mu$ R/h (Fig. 6). A spot measuring  $\sim$ 0.09 m<sup>2</sup> (1 ft<sup>2</sup>) and having surface radiation levels of 16  $\mu$ R/h gamma and 0.03 mrad/h beta-gamma was found in the parking lot about 22 ft north of the building (Fig. 7). A maximum exposure rate of 100  $\mu$ R/h was noted at a depth of 20 cm (8 in.) at that spot.

Locations of systematic (S) and biased (B) soil samples collected outdoors are shown on Figs. 6 and 7, and results of analysis are listed in Table 3. Maximum concentrations of  $^{226}\text{Ra}$ ,  $^{232}\text{Th}$ , and  $^{238}\text{U}$  in systematic soil samples collected from the surface (0–15 cm) were 1.1, 0.91, and 13 pCi/g, respectively. Maximum concentrations of  $^{226}\text{Ra}$ ,  $^{232}\text{Th}$ , and  $^{238}\text{U}$  in systematic soil samples collected from subsurface soil (15–30 and 30–45 cm) were 1.1, 0.92, and 4 pCi/g, respectively. With the exception of uranium concentrations in samples S8A and S8B (13 and 4.0 pCi/g) all values are comparable to those typically found in the Fairfield, Ohio, area (Table 2). The elevated concentrations in samples S8A and S8B are well below site-specific guidelines of 30 to 40 pCi/g  $^{238}\text{U}$  previously applied at other FUSRAP sites (Table 1).

Maximum  $^{226}\text{Ra}$  and  $^{232}\text{Th}$  concentrations in biased soil samples are 5.2 pCi/g and 3.3 pCi/g, which are less than the guideline (Table 1). Concentrations of  $^{238}\text{U}$  ranged from 1.4 to 4.3 pCi/g in samples from locations B4, B5, and B6. However,  $^{238}\text{U}$  concentrations were elevated up to 450 pCi/g and 2900 pCi/g in soil samples from locations B1 and B2. The maximum  $^{238}\text{U}$  concentrations exceed the 30 to 40 pCi/g site-specific guideline value (Table 1, footnote d). Sample collection at those two spots effectively remediated the contamination.

**Fig. 6. Diagram showing surface gamma exposure rate measurements and locations of soil samples collected in the area west of the building prior to construction activities (July 1992)**

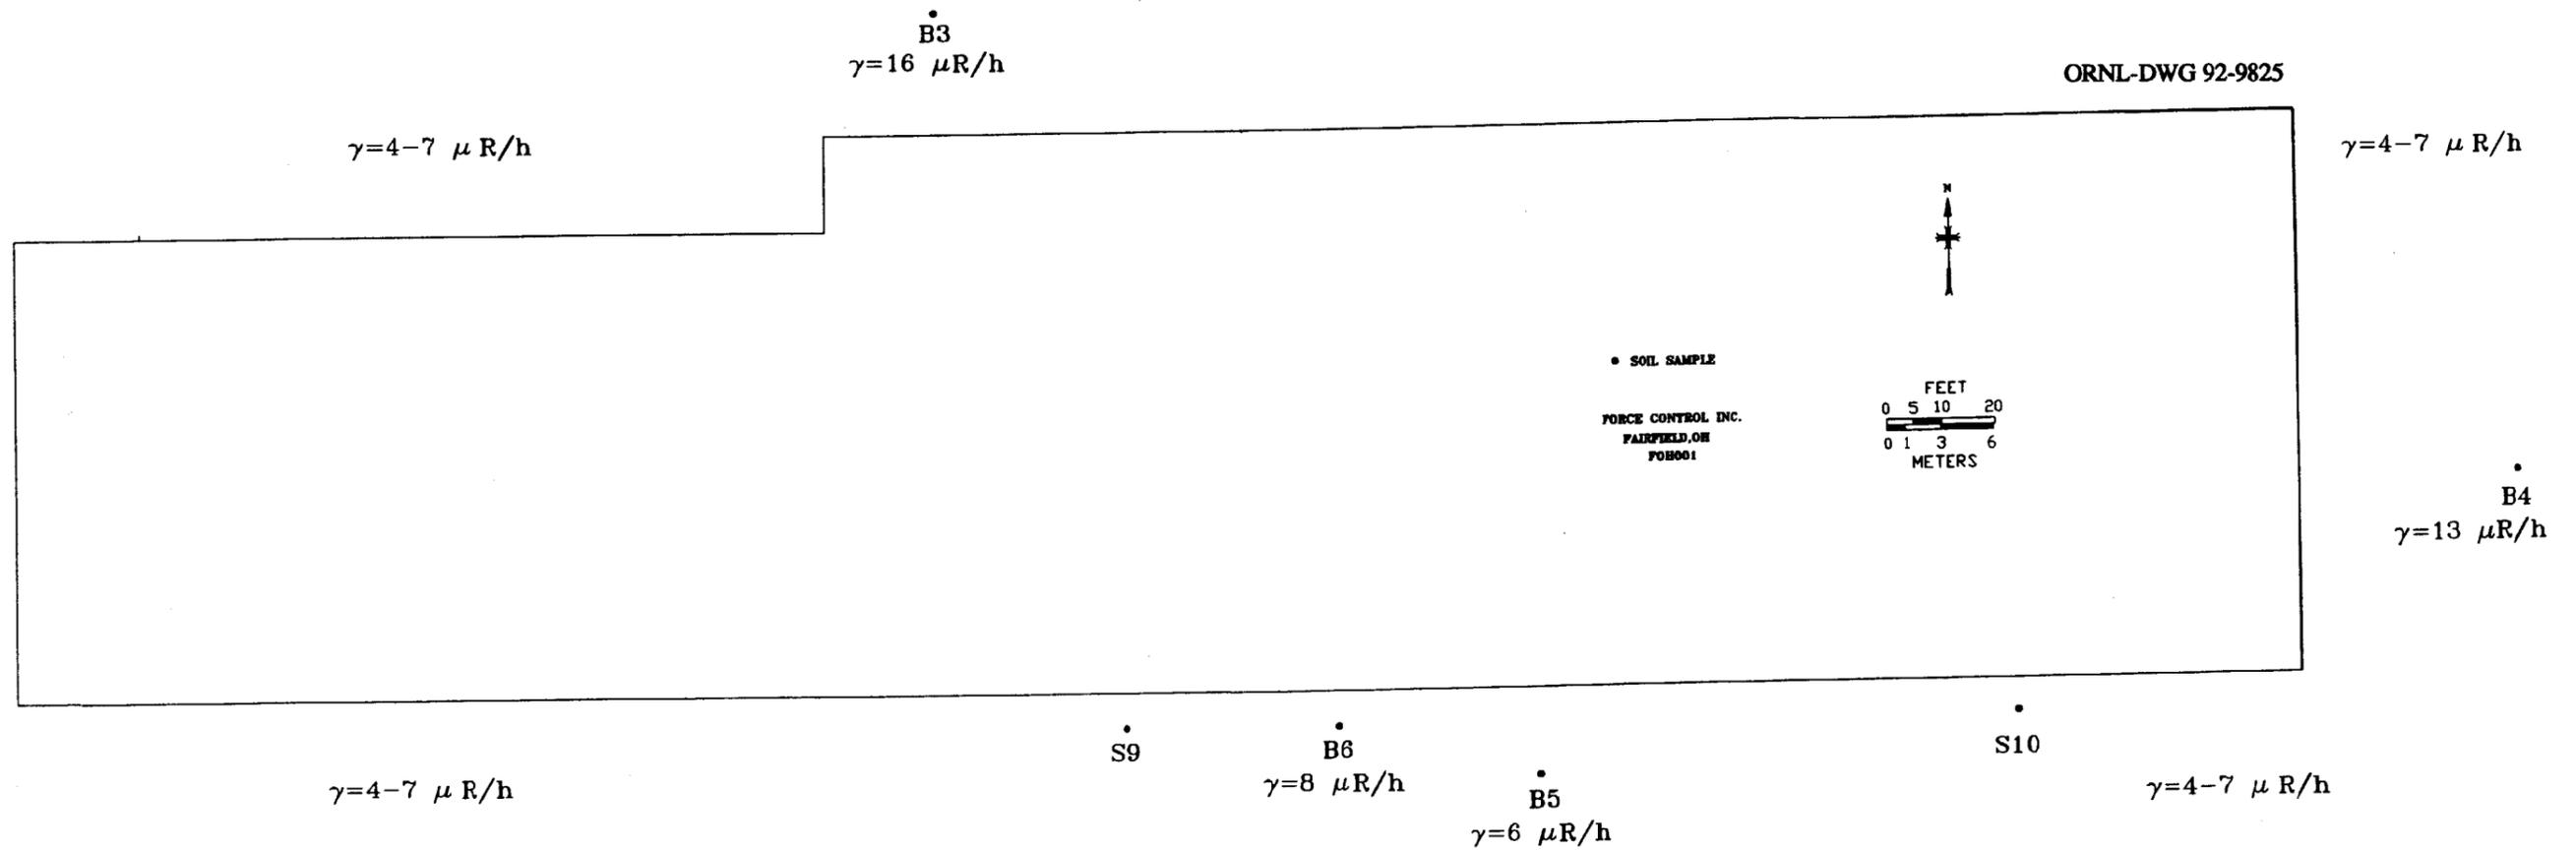
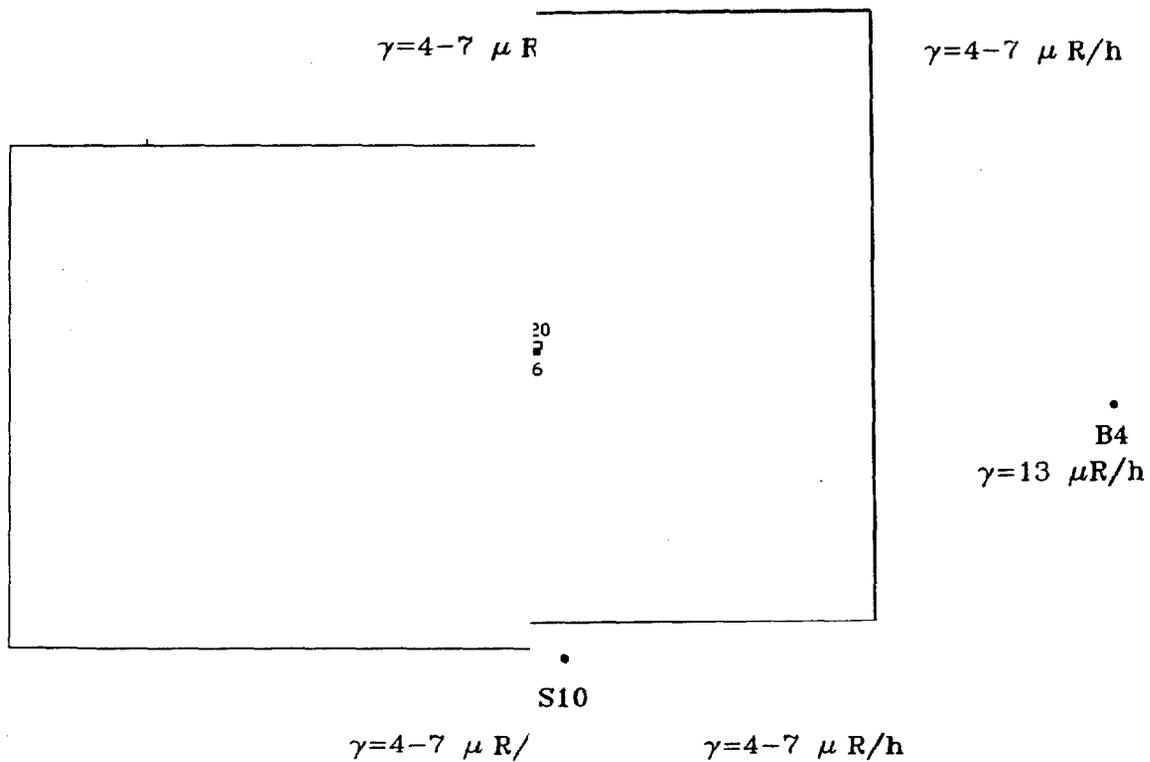
Fig. 7. Diagram showing surface gamma exposure rate measurements and locations of soil samples collected outdoors in September 1992.

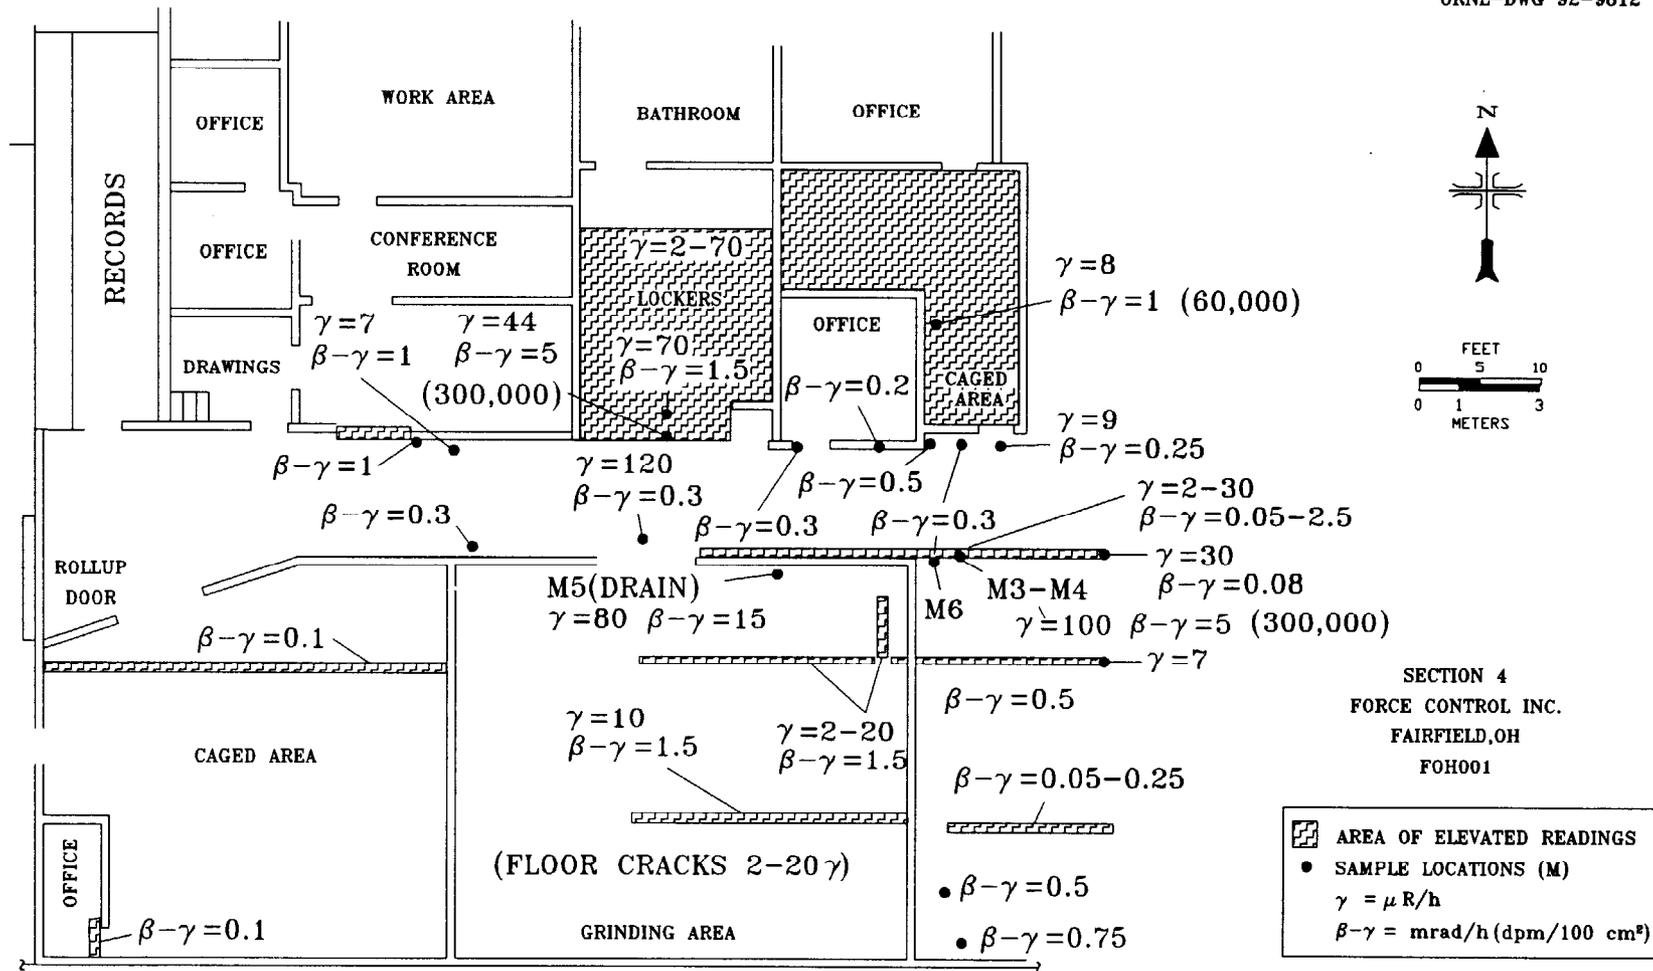
**Section 4.** A caged area and adjoining locker room in Section 4 were generally contaminated as shown by the hatching on Fig. 9. Gamma exposure rates in the caged area were background ( $8 \mu\text{R/h}$ ) but beta-gamma activity levels of  $60,000 \text{ dpm}/100 \text{ cm}^2$  ( $1 \text{ mrad/h}$ ) exceed the average surface contamination guideline of  $5000 \text{ dpm}/100 \text{ cm}^2$  by a factor of 12 (Table 1). Gamma exposure rates in the locker room were a maximum of  $70 \mu\text{R/h}$  and beta-gamma dose rates reached  $5 \text{ mrad/h}$  ( $300,000 \text{ dpm}/100 \text{ cm}^2$ ). Miscellaneous spots and floor cracks in the south end of Section 4 had radiation levels in excess of DOE guidelines. Gamma exposure rates were as high as  $120 \mu\text{R/h}$  at a spot just north of the door into the grinding area. Individual spots in the cracks had gamma exposure rates ranging from  $50$  to  $160 \mu\text{R/h}$ . The associated beta-gamma dose rate was  $0.3 \text{ mrad/h}$ , equivalent to an activity level of  $18,000 \text{ dpm}/100 \text{ cm}^2$ . Gamma levels were  $100 \mu\text{R/h}$  at a spot in a floor crack outside the northeast corner of the grinding room and beta-gamma activity levels were  $5 \text{ mrad/h}$  ( $300,000 \text{ dpm}/100 \text{ cm}^2$ ).

A drain having gamma exposure rates of  $80 \mu\text{R/h}$  on contact with the surface at floor level had a gamma reading of  $50 \text{ mR/h}$  at 20 in. down into the drain. Radiation levels decreased progressively with depth, measuring from  $10 \text{ mR/h}$  at 30 in. to  $5 \text{ mR/h}$  at 42 in. The drain was located beneath the table as seen in Fig. 10.

Samples of material from floor drains and seams in Section 4 (M samples) were analyzed for radionuclide concentrations. Results are listed in Table 4. Sample locations are shown on Fig. 9. Figure 13 shows the survey team collecting samples from a floor seam.

Concentrations of  $^{226}\text{Ra}$  and  $^{232}\text{Th}$  in samples M3 through M5D were all below MDAs. Concentrations of  $^{238}\text{U}$  in samples M3, M4, (both from the floor seam) and M5 ranged from 2000 to 62,000 pCi/g. At location M6, a hole was drilled and concrete dust samples were collected to assess the possibility that multiple layers of concrete might be sandwiching the contamination that was found in the nearby seam (M3 and M4 samples). Maximum subsurface concentrations of  $^{226}\text{Ra}$ ,  $^{232}\text{Th}$ , and  $^{238}\text{U}$  in M6 samples were 0.58, 0.30 pCi/g, and 5.9 pCi/g, respectively. These results are comparable to background values typical for concrete. The concrete floor did not appear to be layered.

Fig. 9. Drawing showing directly measured radiation levels and sample locations in Section 4 of the building at the former Associate Aircraft site.

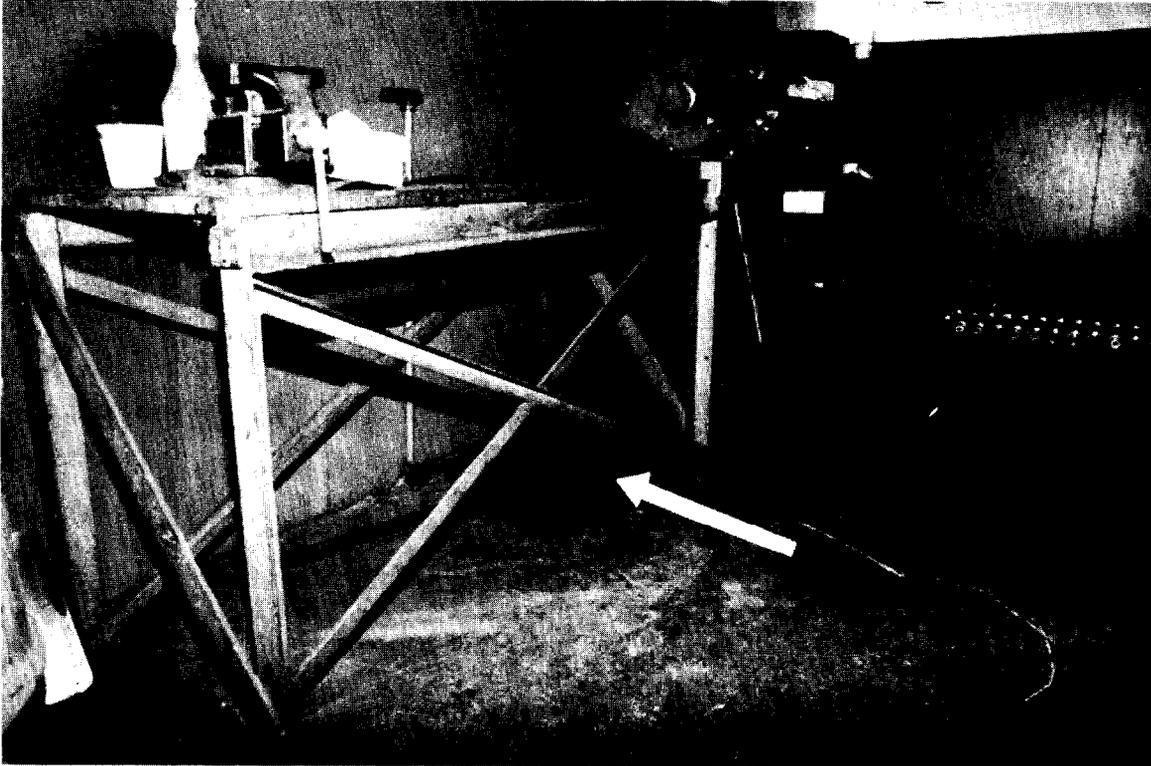
**Fig. 10. Photograph showing the location of the the floor drain (M5) in Section 4 of the building at the former Associate Aircraft site. Drain is located beneath the table as indicated by the arrow.**

since significant quantities of radioactive materials were found in the system. Because two distinct areas of soil contamination were found outdoors and the transport mechanism is not apparent, it is recommended that any subsequent examination incorporate all areas of the property as it existed when the uranium work was performed.

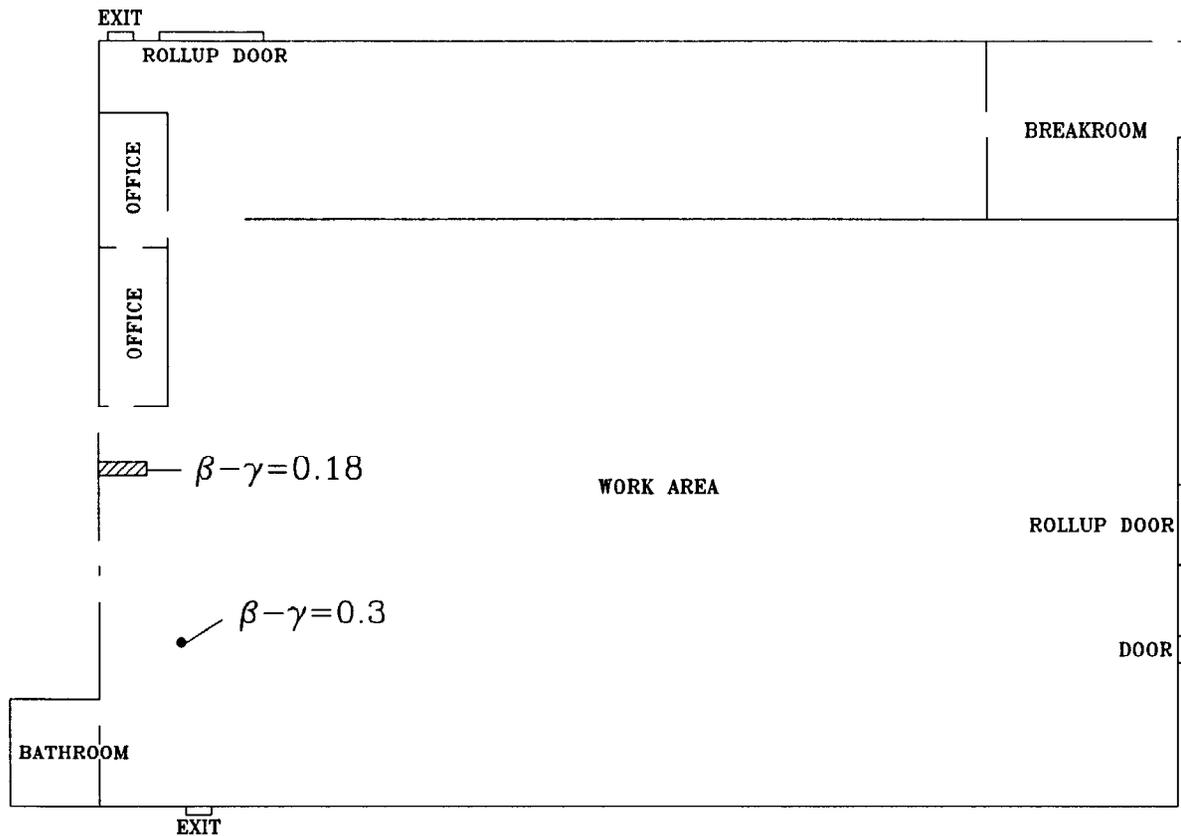
**Section 5.** This area was generally uncontaminated with the exception of 2 small spots on the floor near the offices between the N and S exits (Fig. 11). Beta-gamma dose rates at those spots were  $0.3$  and  $0.18 \text{ mrad/h}$  ( $18,000$  and  $10,500 \text{ dpm}/100 \text{ cm}^2$ , respectively). The spots are above the total (fixed plus removable) dose rate guideline and the average activity level guideline (Table 1).

**Fig. 11. Drawing showing directly measured radiation levels in Section 5 of the building at the former Associate Aircraft site.**

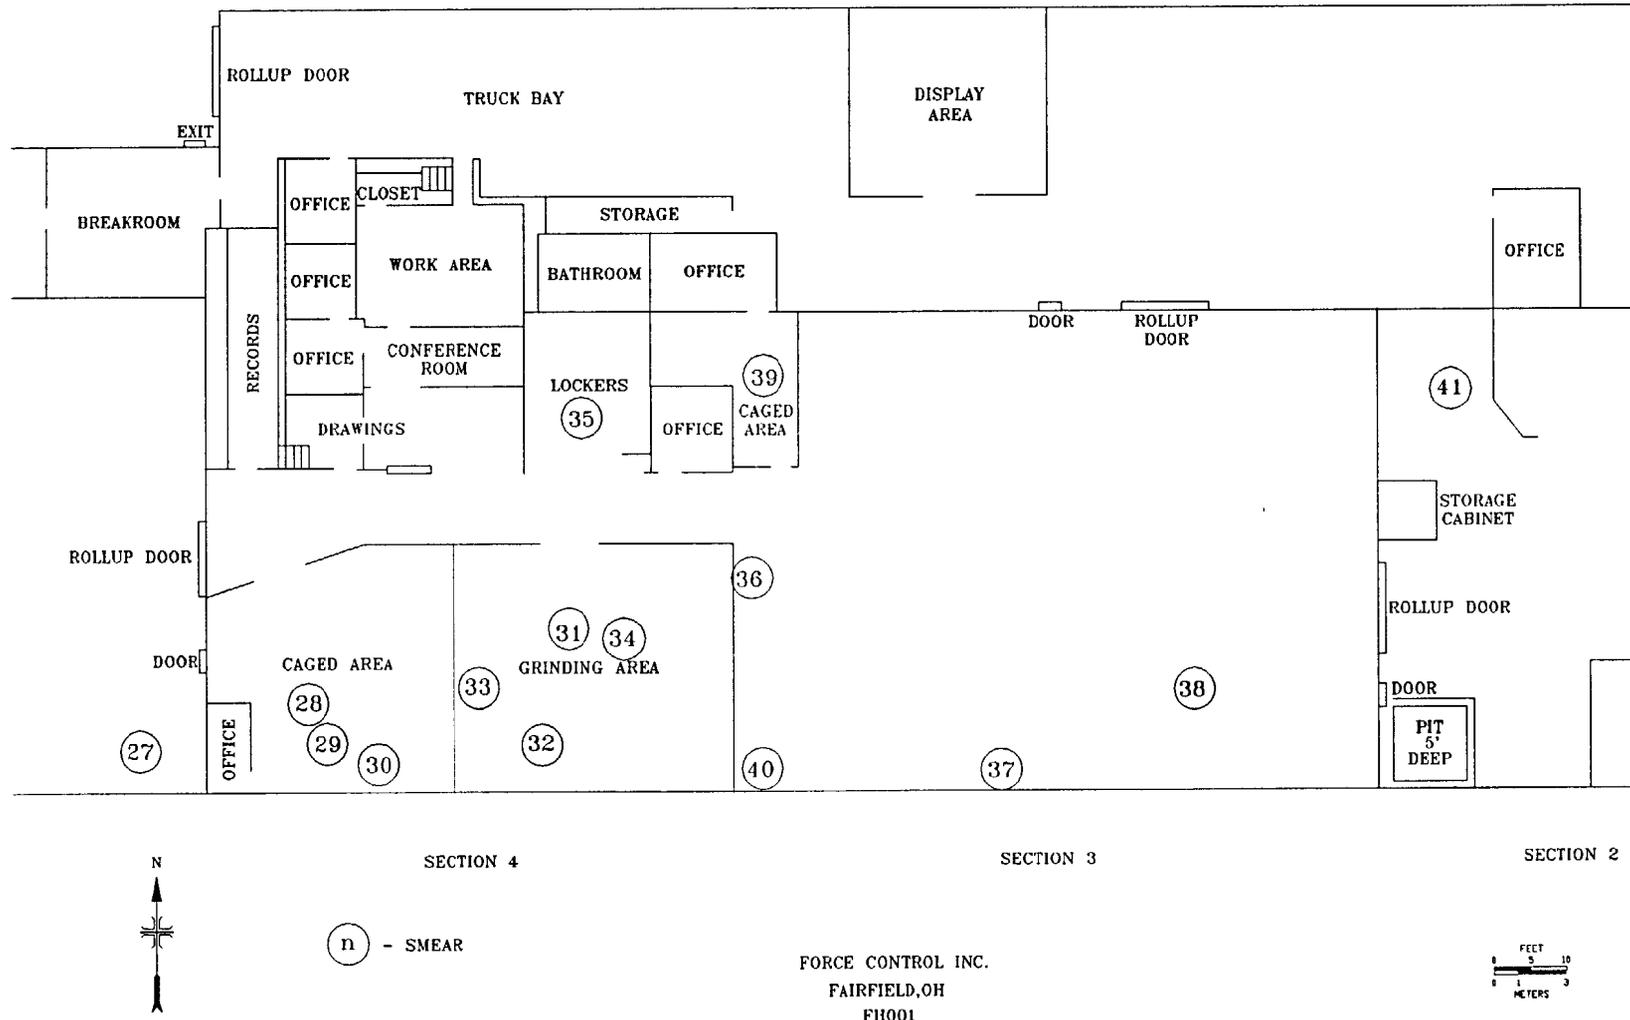
The locations of 15 smears (numbered 27 through 41) collected from equipment and structural surfaces near or at floor level in the building are shown on Fig. 12. Analysis results for alpha activity levels in all samples were less than the minimum detectable activity (MDA)\*. Five of the 15 smears showed beta-gamma activity levels of more than MDA. Those results ranged from 6 to  $12 \text{ dpm}/100 \text{ cm}^2$ , well below the  $1000 \text{ dpm}/100 \text{ cm}^2$  for removable activity levels resulting from uranium contamination (Table 1).

**Fig. 12. Diagram showing locations of smears taken on equipment and structural surfaces near floor level in the building at the former Associate Aircraft site.**

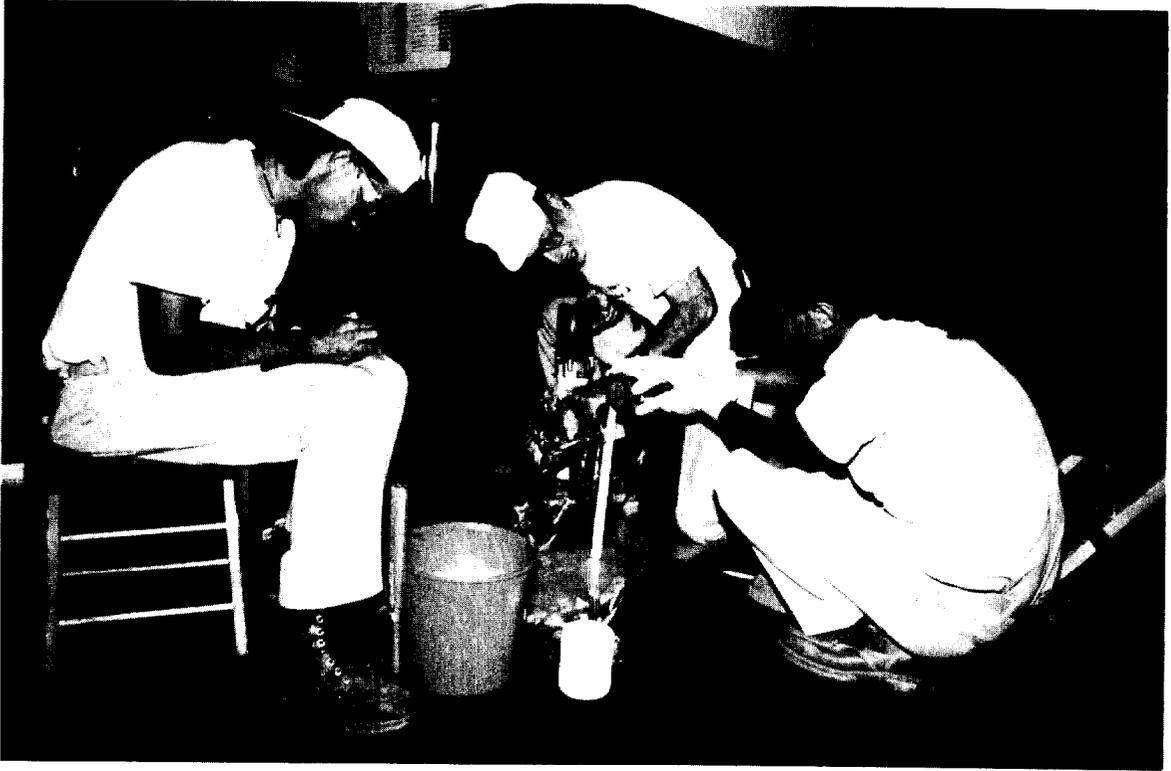
**Fig. 13. Photograph of survey team accessing the floor seam in Section 4 to collect samples M3 and M4.**

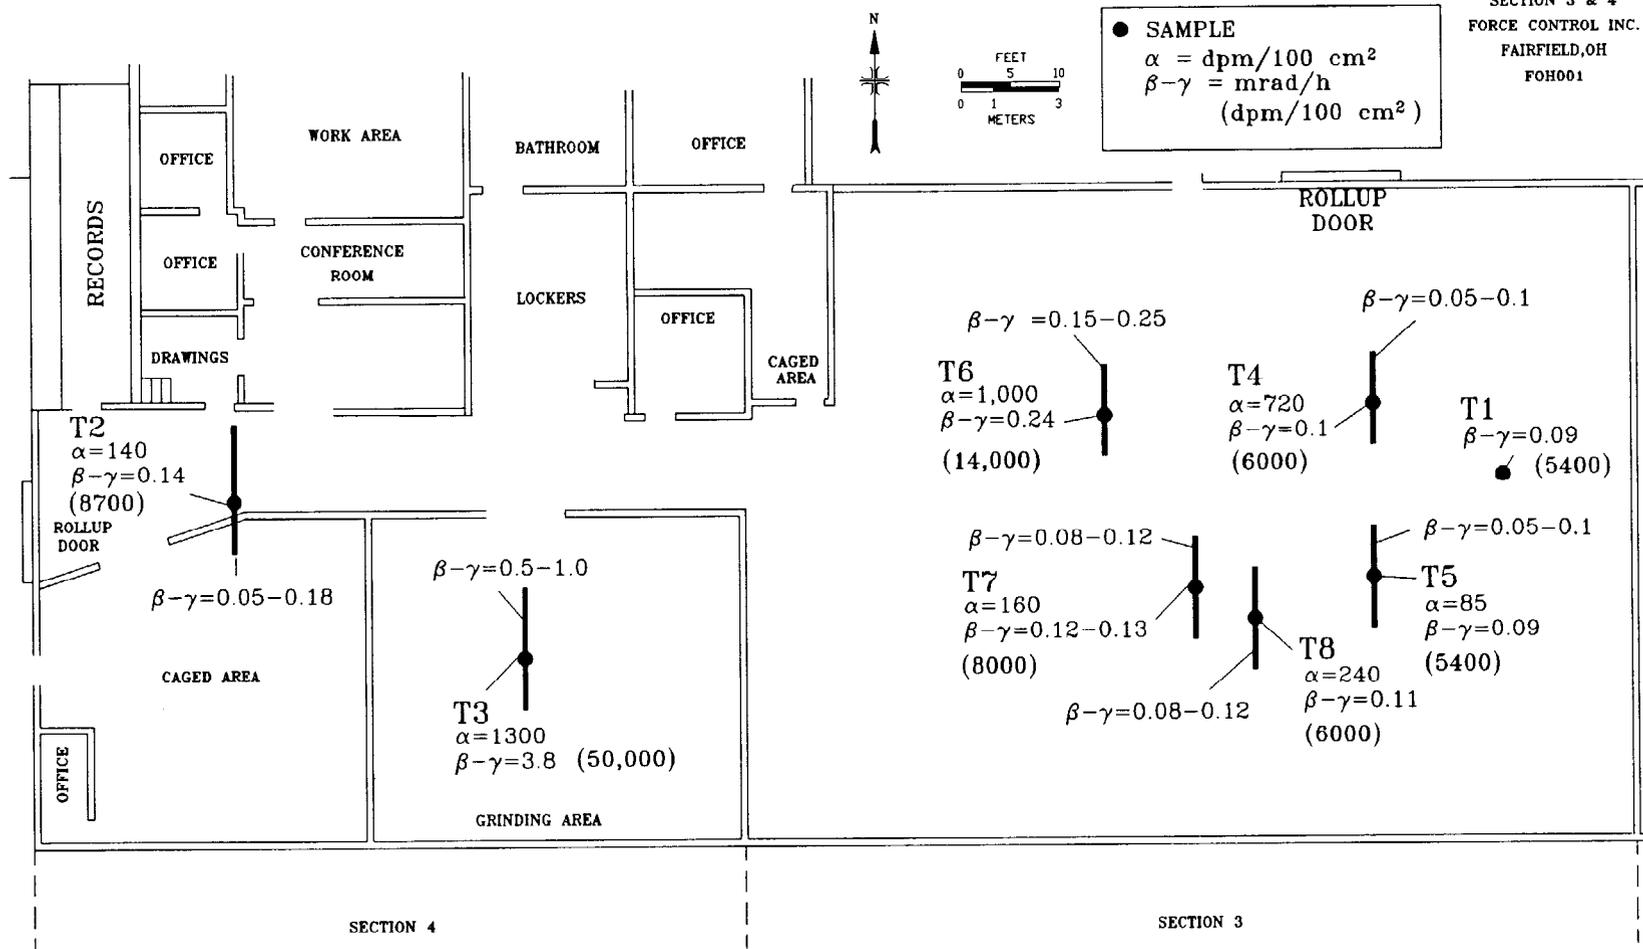
Dust samples (T1B—T8B) were collected from overhead beams in eight locations showing elevated total alpha and/or beta-gamma activity levels (Fig. 14). Smear samples (T1A—T8A) were collected from the surfaces after the dust was removed. The direct radiation measurements, the results of radionuclide analysis of smears and dust samples, and the derived removable beta-gamma activity levels for the eight locations are detailed in Table 5. Figure 15 shows the survey team collecting overhead measurements.

Directly measured alpha activity levels on overhead beams in Section 3 at six sample locations (T1, T4—T8) were 85 to 1000 dpm/100 cm<sup>2</sup>, values below the DOE guideline for total (fixed and removable) alpha emitters. However, beta-gamma dose rates at those locations ranged from 0.09 to 0.24 mrad/h (5400 to 14,000 dpm/100 cm<sup>2</sup>), exceeding guidelines for dose rates of 0.2 mrad/h over an area not more than 1 m<sup>2</sup> and the average surface contamination level of 5000 dpm/100 cm<sup>2</sup>.

Directly measured alpha activity levels on beams in Section 4 were 140 and 1300 dpm/100 cm<sup>2</sup> in two locations. These values are below guidelines (Table 1). Total beta-gamma dose rates were 0.14 and 3.8 mrad/h (8700 and 50,000 dpm/100 cm<sup>2</sup>), exceeding dose rate and average surface contamination guidelines.

Fig. 14. Diagram showing directly measured radiation levels and locations of samples on overhead structures in the building at the former Associate Aircraft site.

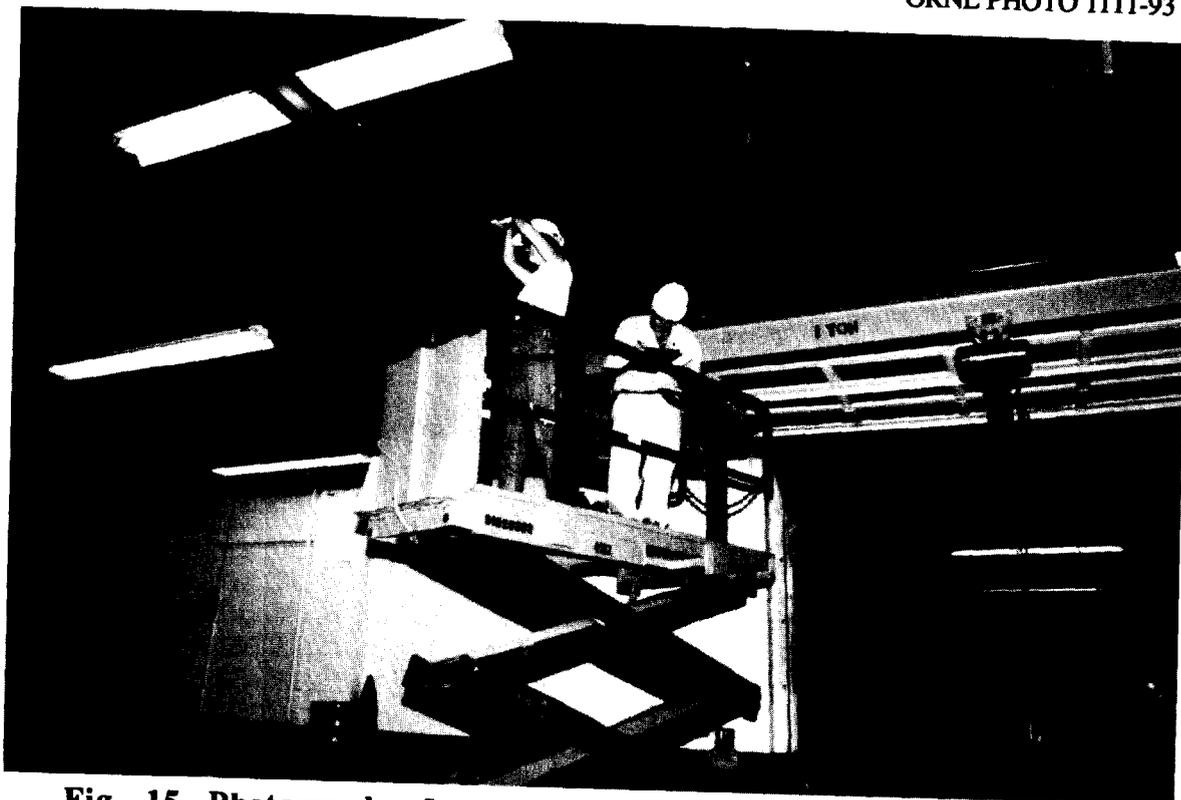
**Fig. 15. Photograph of survey team taking radiation measurements on overhead beams.**
